GENERAL CORROSION AND CORROSION UNDER DEPOSITS ON A TUBE FOR AN AIR FIN COOLER SYSTEM

Zaifol Samsu, Mohd Harun, Mahdi E. Mahmoud, Norasiah Ab Kasim, Katrul Hisham Alahudin, Zaiton Selamat

Material Technology Group, Industrial Technology Division, Malaysian Nuclear Agency zaifolsamsu@nuclearmalaysia.gov.my

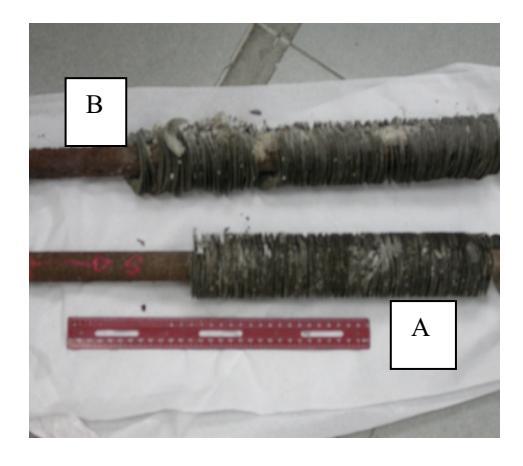
Fig. 1. Samples of cooler tube

The two cooler tubes labeled A and B along with the aluminum fin were investigated (Figure 1). The fins were filled with a whitish looking corrosion product (Aluminum Oxide), and this byproduct was trapped between the aluminum fins, covering the reddish corrosion product. Figure 2 shows the tube A and B after the aluminum fins were removed. This shows the rust covered tube surface, which is red in color (Fe₂O₃).

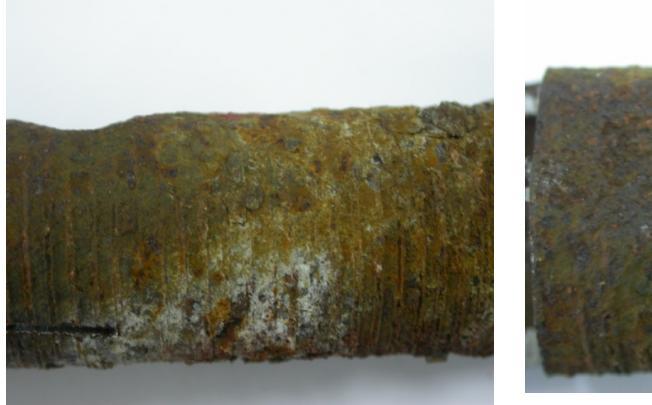
Fig. 3(a). The valley at point P by side view

Tube A consists of a valley P (Figure 3(a)) and a hole Q (Figure 3(b)). A valley at point P was formed due to perforation attacks on the tube's surface. SEM analysis shown that the corrosion product formed on the valley at point P has large amounts of Chloride (Cl) and Sulphite (S).

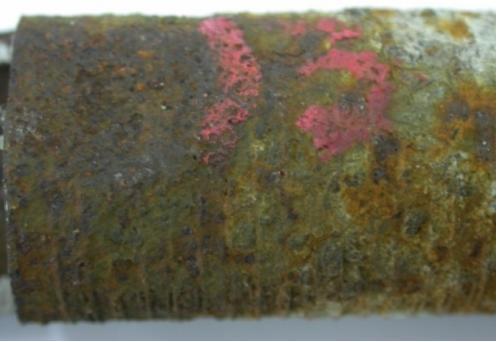
Fig. 3(b). The valley at point P by top view

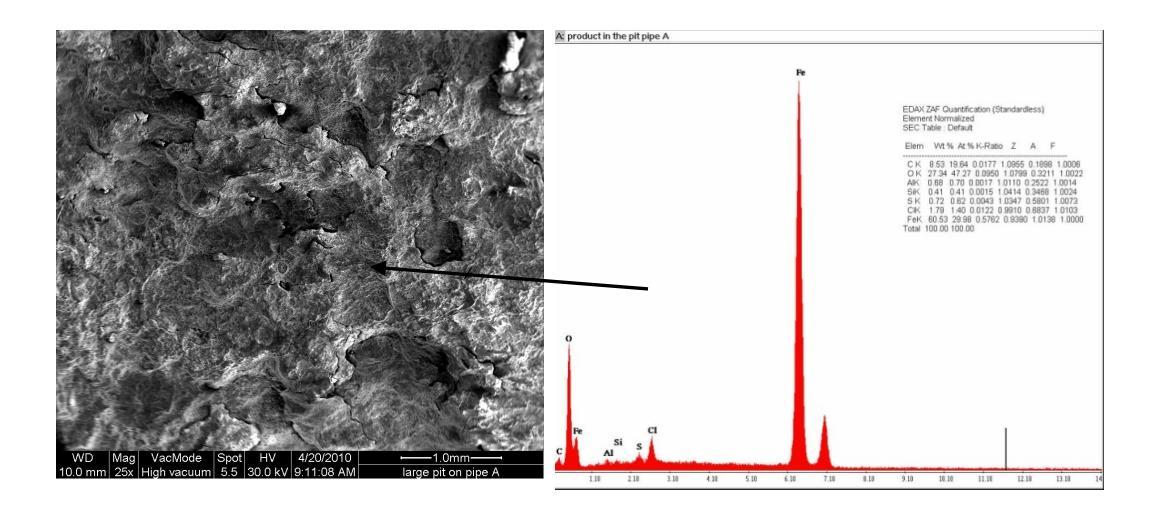
Fig. 4. SEM and EDAX analysis on the valley point P

The concentration of Chloride (Cl) and Sulphite (S) from the corrosive environment acts as an aggressive ion under deposits and is capable of producing severe localized corrosion on the tube's surface. Deposits containing corrosive substances such as sulfur-containing and chloride-containing species serve as an occluding medium which develops concentration cells (1).

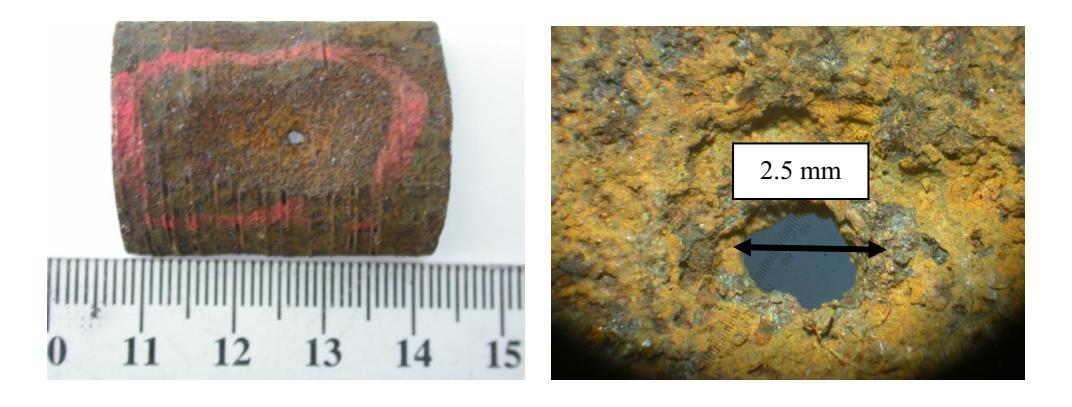
Fig. 4(a).Defect at point Q

Fig. 4(b). Dimension of hole at point Q

The continuous attack from aggressive ions caused the formation of the hole at point Q, as shown in Figure 4. Figure 4 shows a deepening region with a flat surface (internal) around the hole (Figure 4(c)). It is confirmed that the perforation process started from the outside of the tube surface, working its way in. The size of the holes at the inner surface was about 2.5mm (Figure 4b). The hole on the outer surface is bigger and it gets smaller as it approaches the inner walls.

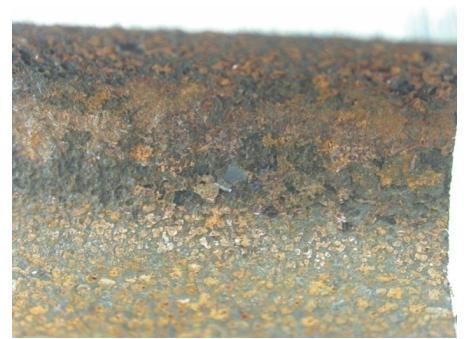
Fig. 4(c). Internal tube surface at point Q

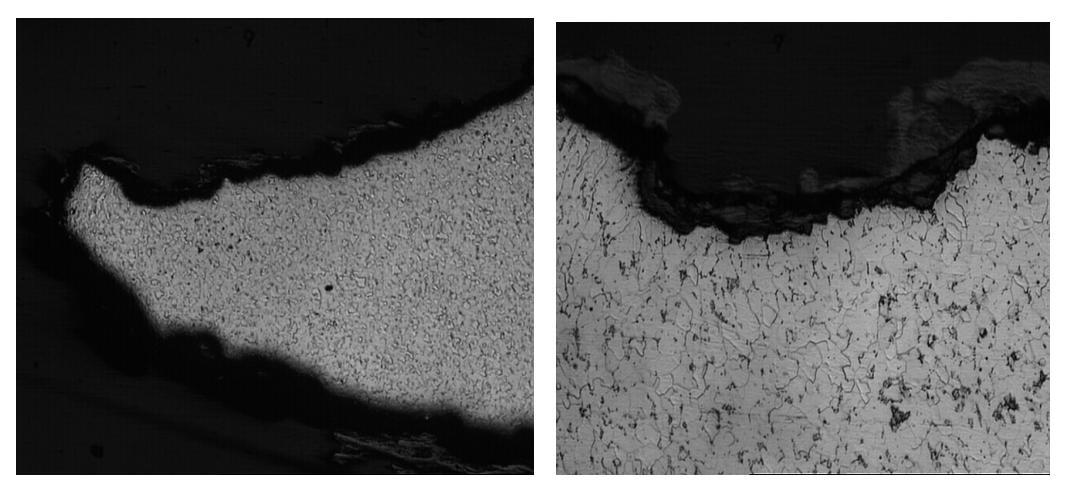
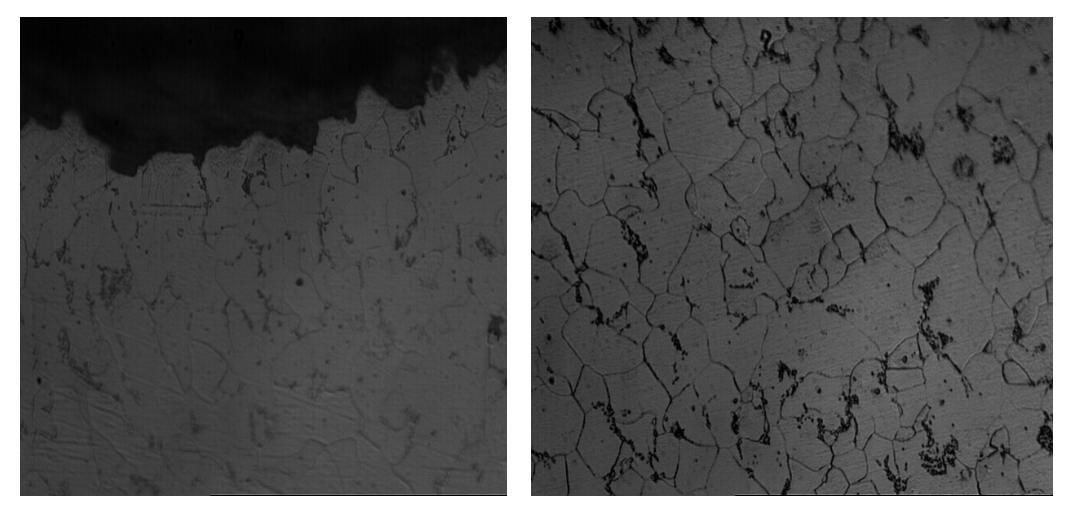
Fig. 5(a). Transverse cross section at hole - X50

Fig. 5(b). X200

Fig. 5(d). X500, at the middle of tube

Perforation attacks at Q on the surface of tube A can be seen in figure 5a. The corrosion occurred at the grain boundaries as shown in Figure 5c-5d. It is caused by the potential difference between the grain boundary region and any precipitates, intermetallic phases, or impurities that form at the grain boundaries (3). The structure consists of ferrite and pearlite (Figure 5d)

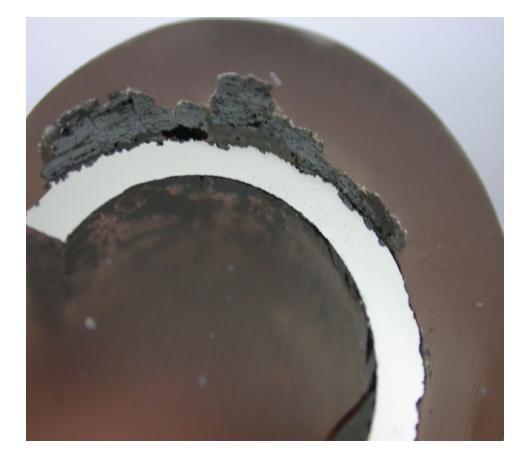
Fig.6. Macro-transverse cross section B General Corrosion attacked on outer surface

Tube B undergoes general corrosion at its outer surface. Figure 6 shows the corrosion product on the outer surface being somewhat rough. This roughness is attributed to an almost uniform corrosion throughout the piece; removing a substantial quantity of metal, by way of dissolving in the environment or reacting with it to produce a loosely adherent, porous coating of corrosion products (3).

In order to prevent corrosion attacks, the tube should be coated with a coating that contain good heat transfer material to avoid direct contact with aluminum fin. The cooler tube should not be exposed to rain water and it should also be subjected to a hydrostatic test before installation.

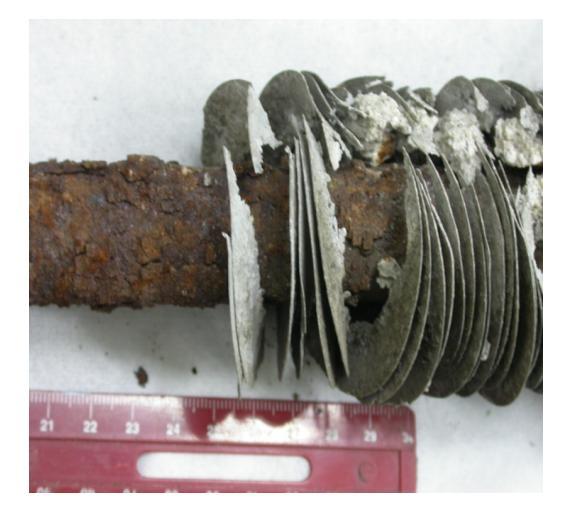
Fig. 7. Aluminium fin

Figure 7 shows the aluminium fin of the cooler tubes. The EDAX analysis (figure 7(a-b)) shows that the fin is purely aluminum. The same analysis was conducted on the corrosion product on the fin's surface and it was shown that the present (dominant) spectrum peaks are of O, S, Cl, Ca, Fe, Si and Na element respectively (Figure 8).

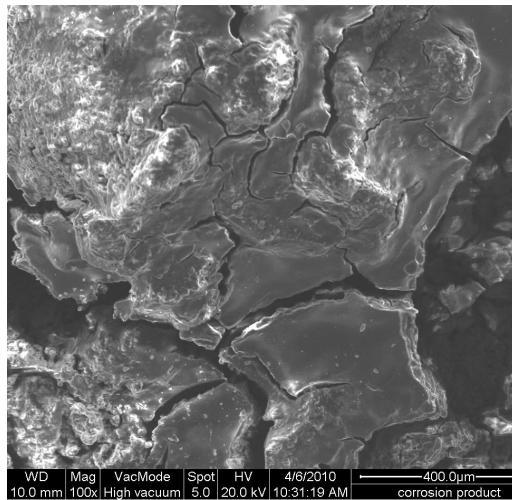
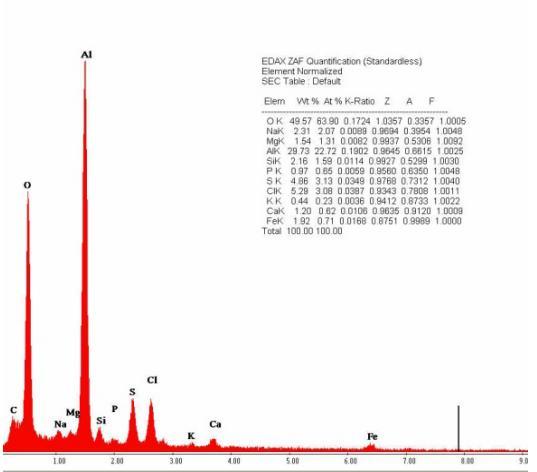
Fig. 8a. Corrosion product on Al surface

Fig. 8b. EDX analysis on the product (scan analysis)
