GENERAL CORROSION AND CORROSION UNDER DEPOSITS ON A TUBE FOR AN AIR FIN COOLER SYSTEM

Zaifol Samsu, Mohd Harun, Mahdi E. Mahmoud, Norasiah Ab Kasim, Katrul Hisham Alahudin, Zaiton Selamat

Material Technology Group, Industrial Technology Division, Malaysian Nuclear Agency zaifolsamsu@nuclearmalaysia.gov.my

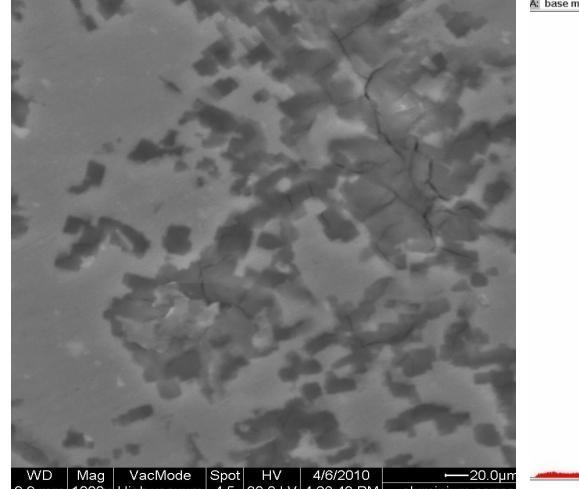
Fig. 7a. Aluminum surface X 1K

Figure 7 shows the aluminium fin of the cooler tubes. The EDAX analysis (figure 7(a-b)) shows that the fin is purely aluminum. The same analysis was conducted on the corrosion product on the fin's surface and it was shown that the present (dominant) spectrum peaks are of O, S, Cl, Ca, Fe, Si and Na element respectively (Figure 8).
