STUDY OF A PIPE INNER CONDITIONS USING A THERMOGRAPHIC METHOD

Abdul Aziz Mohamed¹, Ibrahim Ahmad¹, Muhammad Aidiyat Ismail¹,
Shukri Mohd²

¹Centre for Nuclear Energy, College of Engineering, Universiti Tenaga Nasional, 43000
Kajang, Selangor, Malaysia.

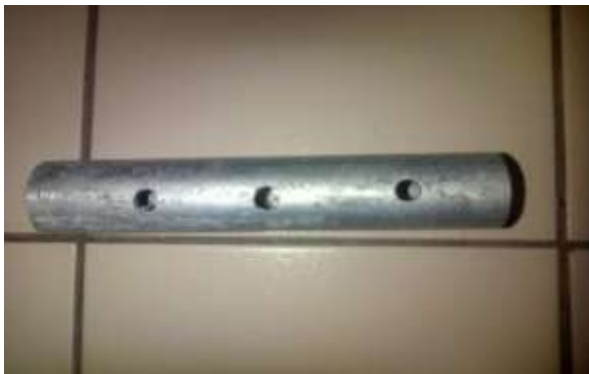
Figure 1: Holes discontinuities.

made for each specimen tube, namely, hole, welded slug and straight line. Figure 1, 2 and 3 show the finished specimen.

The holes are drilled with a same depth but with different diameter. During the process there is a slight different in depth even though the depth is set to be identical. It is a tough process to make the hole with a different depth as the thickness of the steel tube is too small. The objective of this discontinuities represent in a holes form is to observe the thermal behaviour of the material with a different size of discontinuities. Slug is made by using the arc welding equipment. The slug represents some kind of scaling discontinuities which are very common type of discontinuities found in the pipeline. Scaling is a defect form by the build-up of material flowing along with the liquid in the pipe where the thickness of the pipe is increasing and thus increasing the resistance to the liquid flow. There is no significant of existing discontinuities is presented by this artificial defect. But the line is purposely made with a different depth between these two discontinuities at the both end of the tube. The width of the discontinuities is identical but the depth is totally different. The objective of this discontinuities made is to observe the thermal behaviour of the material with a different defect depth.

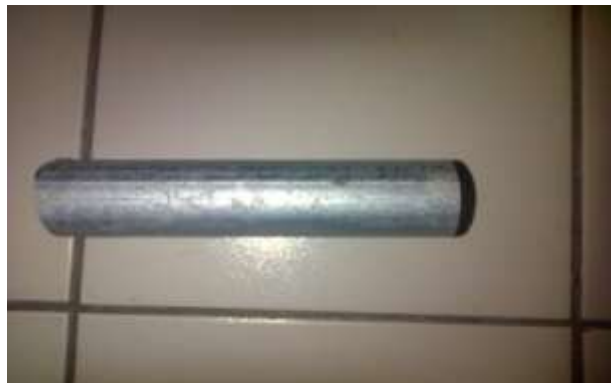
Figure 2: Steel tube for welded slug and straight line discontinuities.

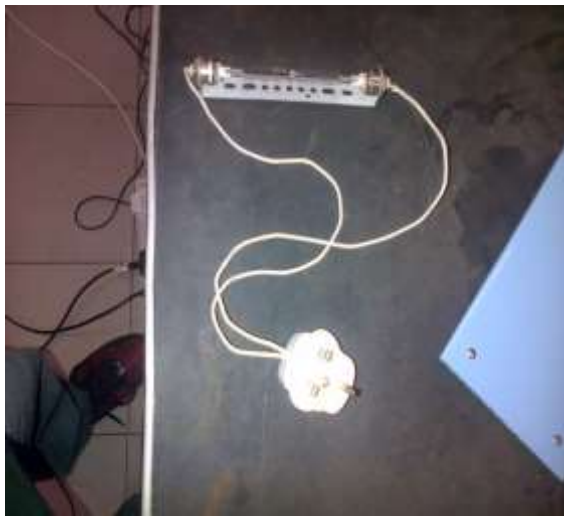
Figure 4: Heat source used.

In choosing the type of heat source the specification is need to satisfy the power requirement for heating up the specimen. It has been a significant step to be taken in choosing the heat source with a certain specification as every type of material having its own power requirement of the heat source in order to heat up the specimen. For this project the material used is galvanized steel so the power required to heat up this specimen should be sufficient to heat up this type of material. The power output of the heat source is considered as changing variable where the amount of power able to be change for a certain type of result desire. For this experiment the amount of heat source power is keep constant with 300watt. If the power is not sufficient enough to heat up the specimen the distant of the spotlight and the tested specimen should be reduce. The heat source specification is as follows (see Figure 4):

- 1) Power: 300 Watt
- 2) Model: self-fabricated

- 3) Heat source: Halogen lamp
- 4) Stand holder: clip

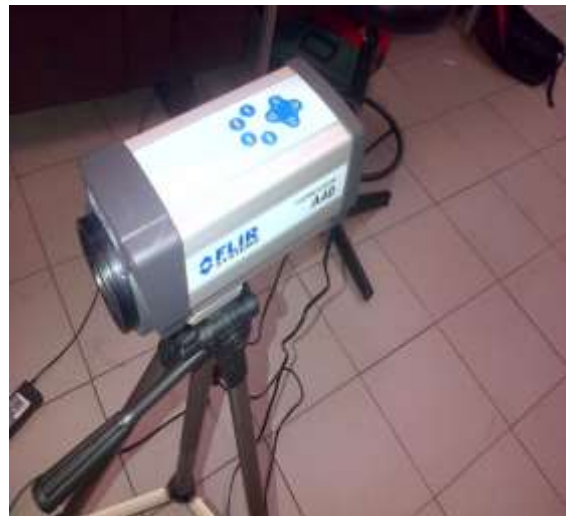
Figure 5: A40 FLIR infrared camera

The camera used in this work is A40 FLIR Infrared camera. The camera is use to capture the image of the heated specimen. The camera is equipped with the tripod and a connecting cable for the laptop. Figure 5 shows the camera.

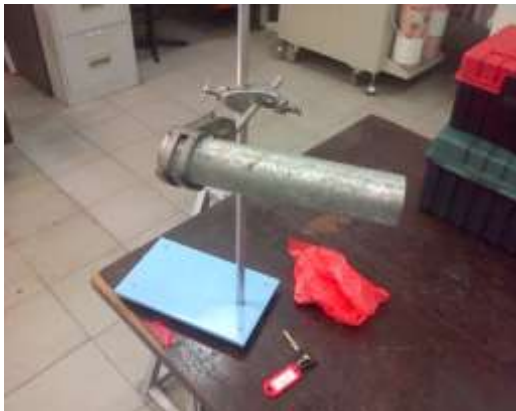
Figure 6: Stand holder and clip.

- i. Stand holder and clip : to hold specimen, see Figure 6.
- ii. Laptop : to acquire image from infrared camera, see Figure 7.
- iii. Halogen lamp with bracket: to heat up the pipe, see Figure 8.
- iv. Thermocouple (K –type): to measure the surface temperature, see Figure 9.

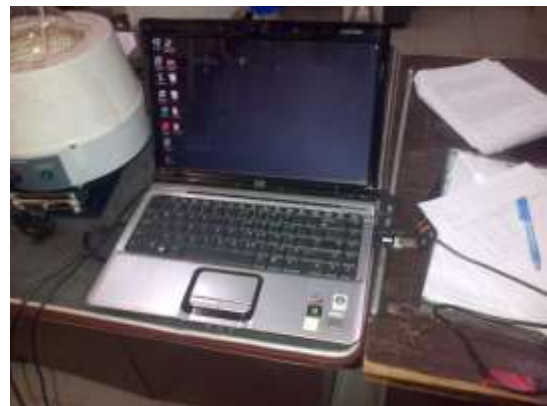
Figure 7: Image acquisition computer.

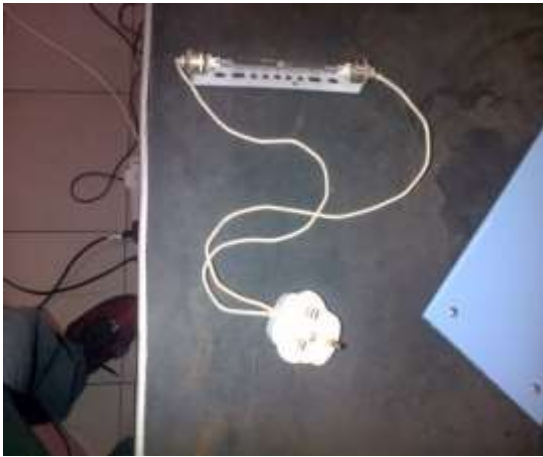
Figure 8: Halogen lamp fabricated with bracket.

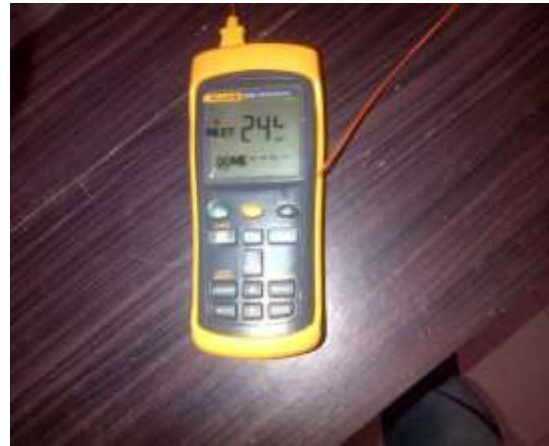
Figure 9: Thermocouple (K –type) reader for the surface temperature measurement.

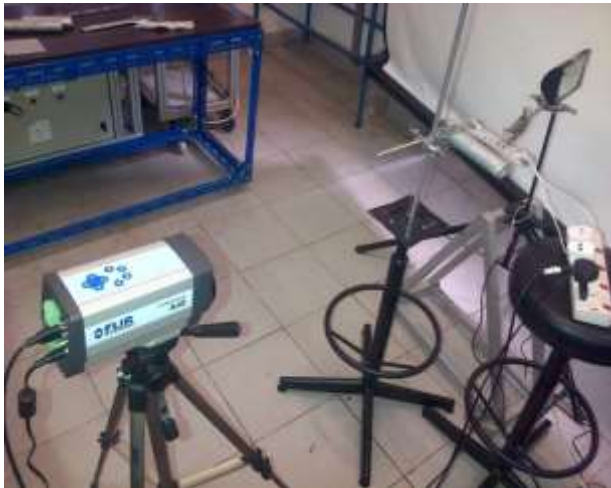
Figure 10: Experiment arrangement.

The procedure of the infrared image acquisition is the following, see Figure 10.

- i. Generate a thermal transient on the surface of the pipe by using the halogen lamp, see Figure 11. The distance of the halogen lamp and the tested specimen is 5 cm.
- ii. Observe the temperature distribution of the specimen with the IR camera and note abnormal temperature patterns resulted from the increasing of surface temperature. Note that the temperature profile having a different thermal contrast for different thickness.
- iii. Image processing and data acquisition.
- iv. Image interpretation and analysis.

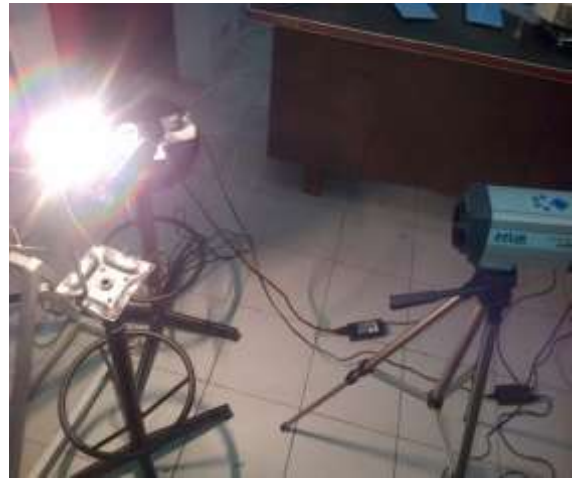
Figure 11: Heating up specimen
